# Gravity Sewer and Water Main Rehabilitation and/or Replacement, Phase 1

## Preliminary Design Report

TWA Project No. 16-060

**Toho Water Authority**  
951 Martin Luther King Jr. Boulevard  
Kissimmee, FL 34741

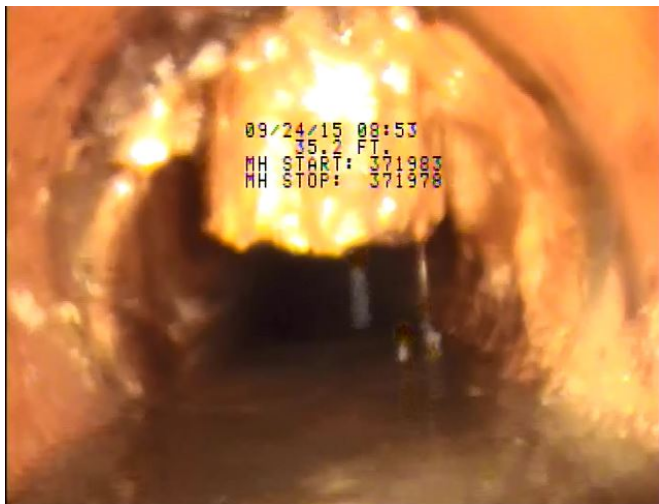
Protruding Lateral and Broken Main

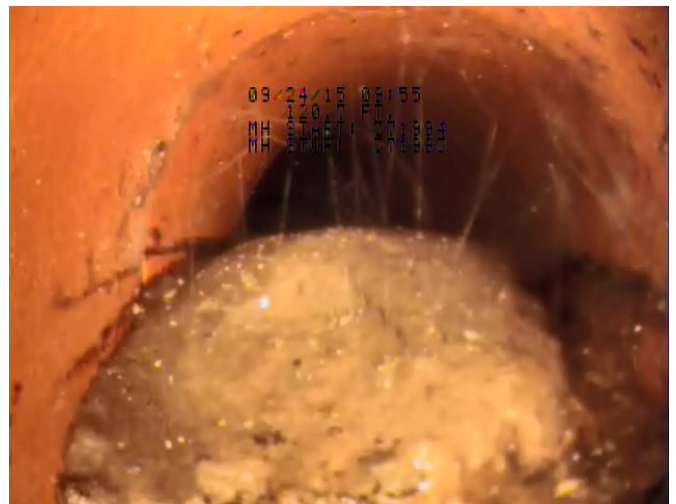
Plugged Active Lateral

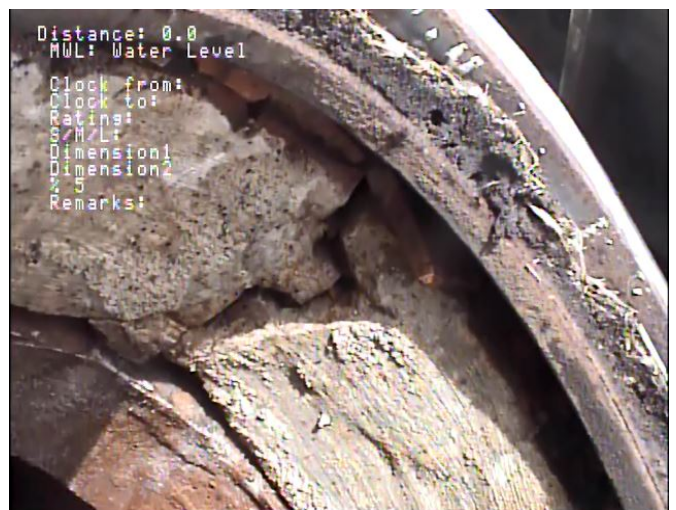
Cracked MH Chimney

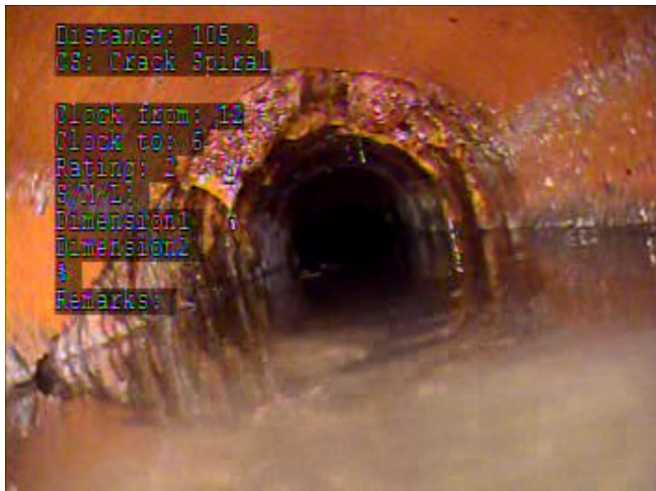
Broken Main

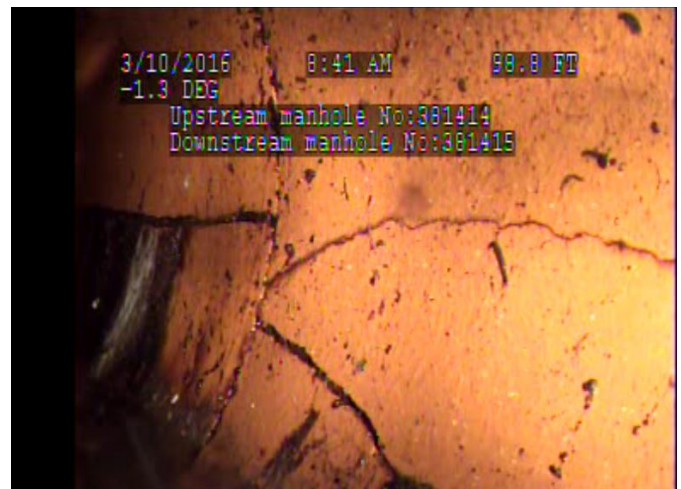
Linear Fracturing

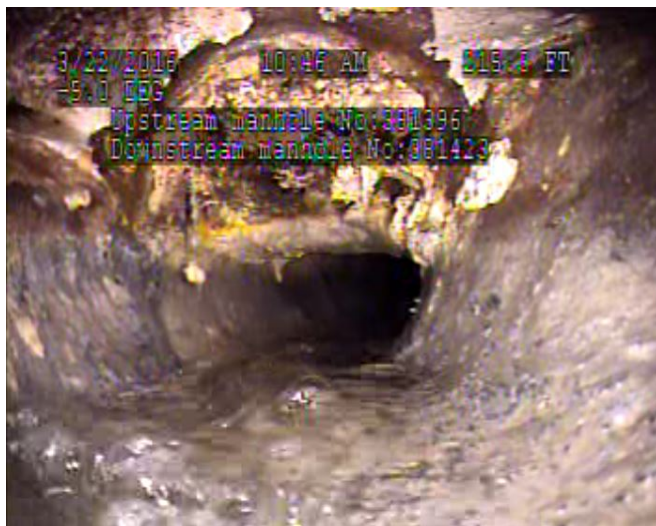
Grease at Crown of Pipe

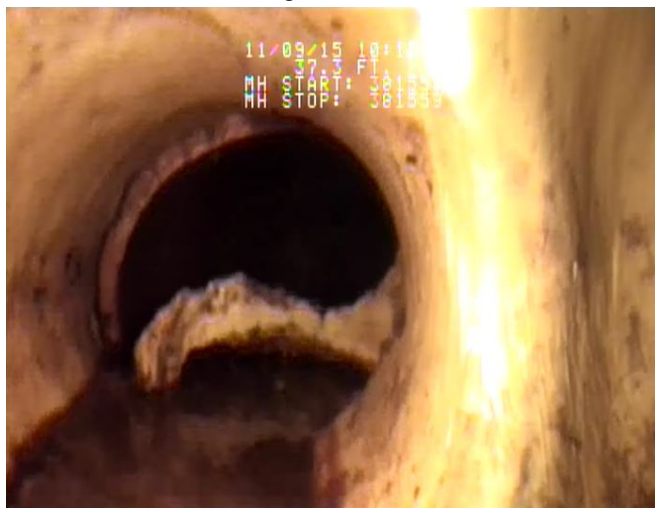
Failing Lateral Liner

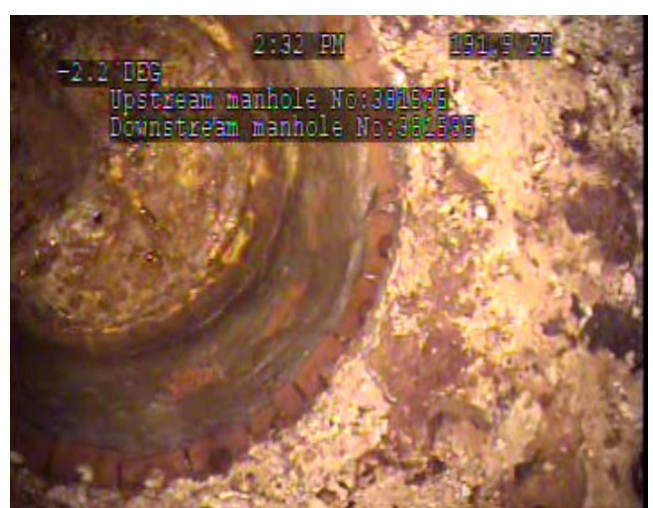
Corroded MH Wall

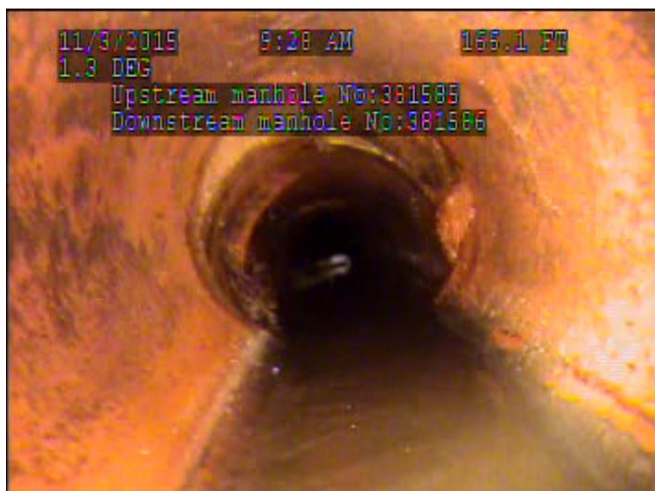
Settled Wye Connection

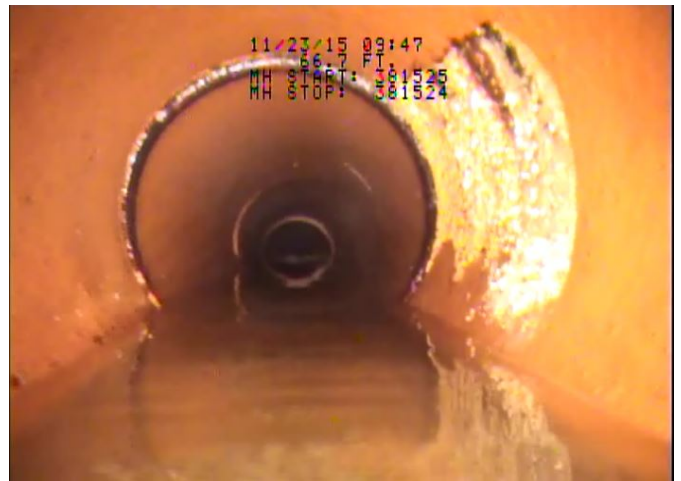
Longitudinal Fracture w I/I Stain

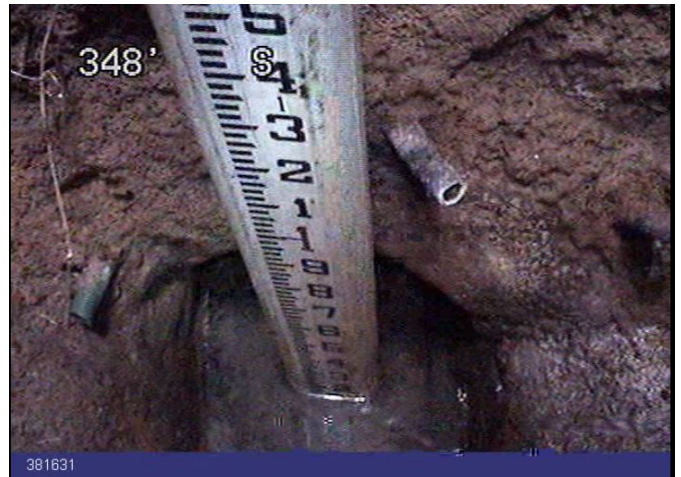
### MH on Uninspected Pipe

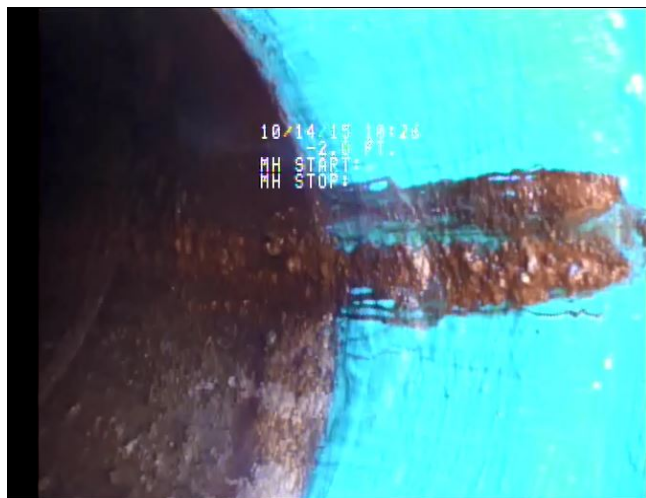
Leaking Chimney Seal

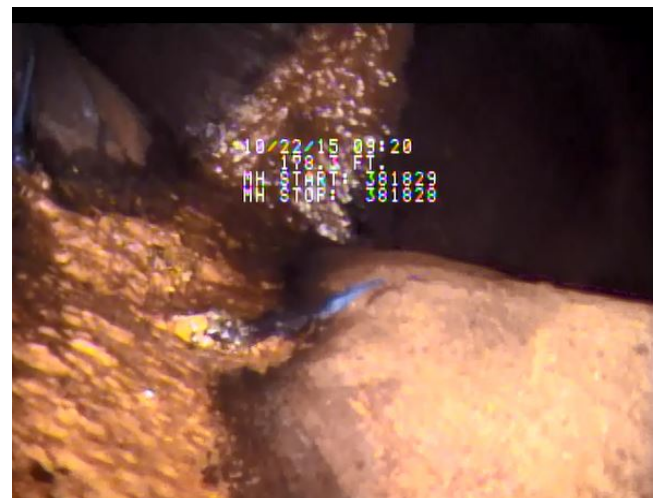
Significant MH I/I

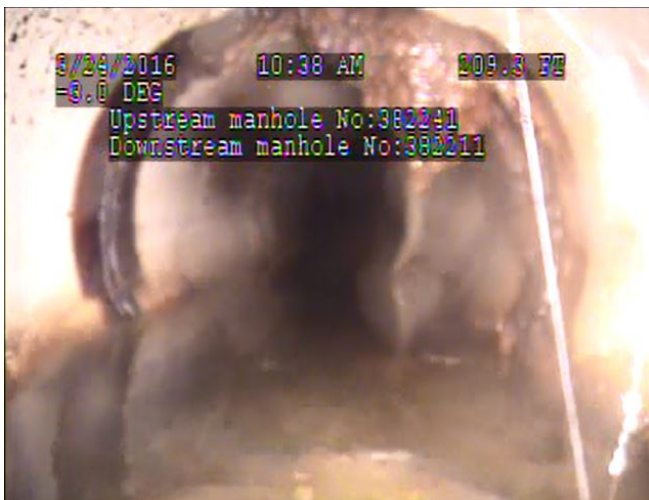
Leaking Break-in Lateral

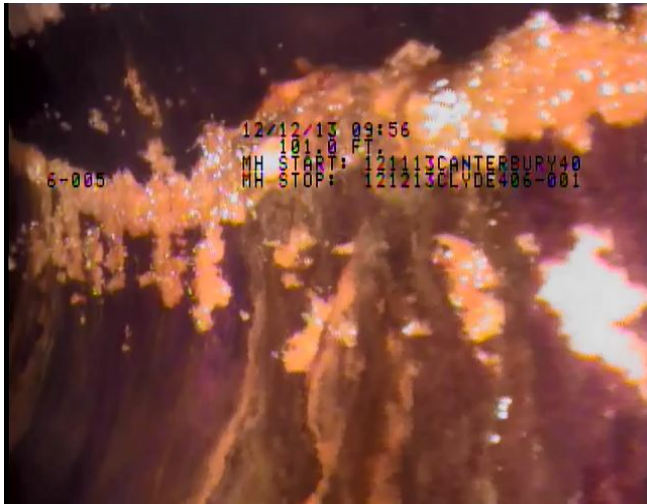
Fractured Liner with I/I

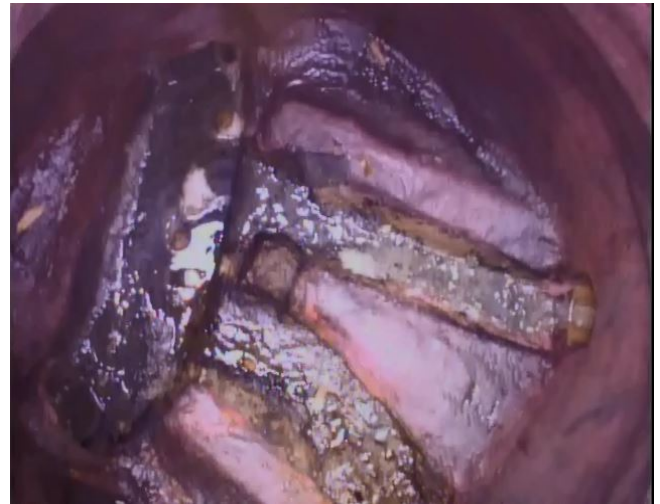
Lined Manhole

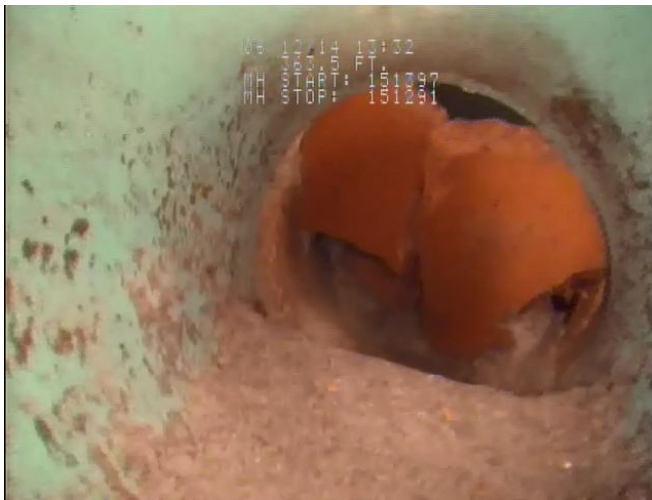
Collapsed Pipe

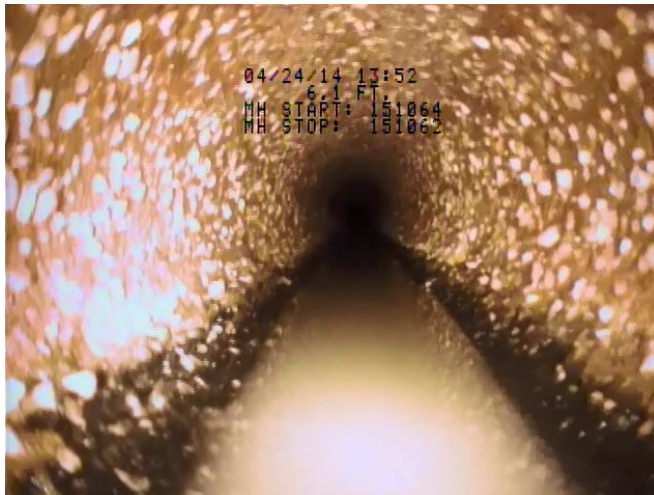
Concrete Pipe Corrosion

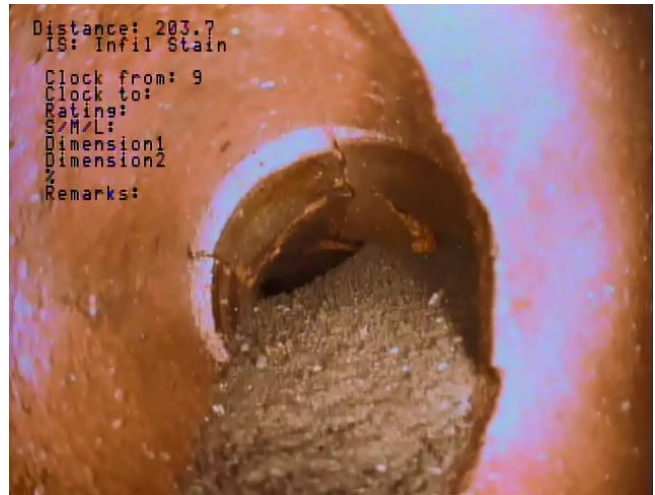
Failed Tap Connection

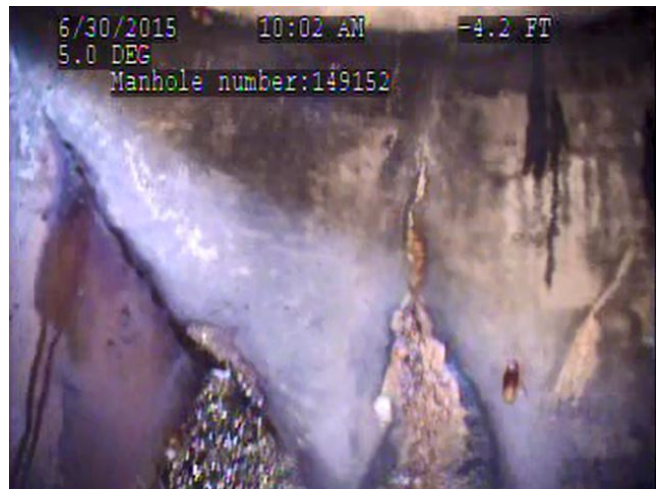
Fractured Manhole Wall

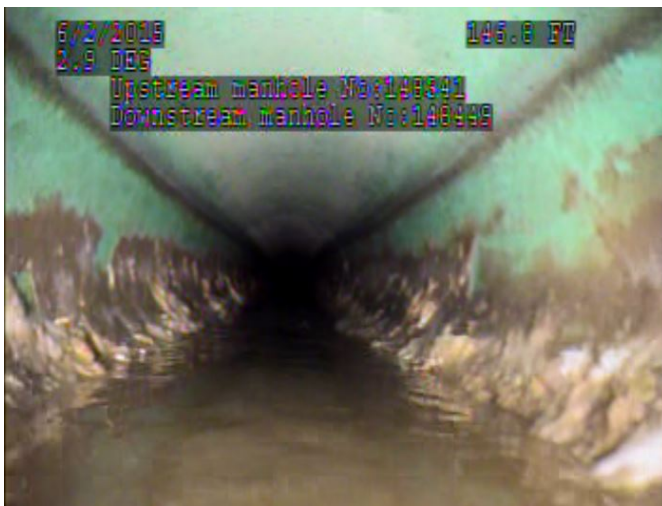
Attached Grease

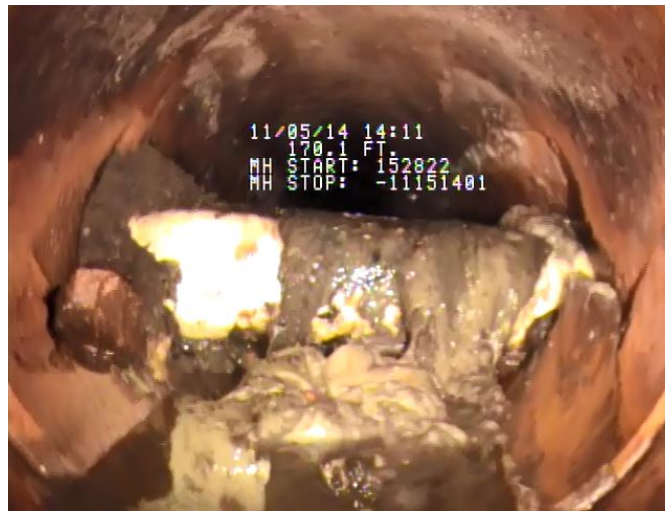
Utility Cross Bore Requiring Spot Repair

There are 20 spot repairs recommended throughout the project area. Spot repairs are called out to fix issues that cannot be corrected through lining alone. Defects such as sags, or offset joints can restrict the equipment used to perform trenchless rehabilitation and need to be corrected in advance of lining. In other cases, spot repairs may be performed to repair a lateral connection that cannot properly be accessed and repaired from the main, or to correct isolated defects on VCP or PVC sewers that are in otherwise good condition (i.e. utility cross-bores).

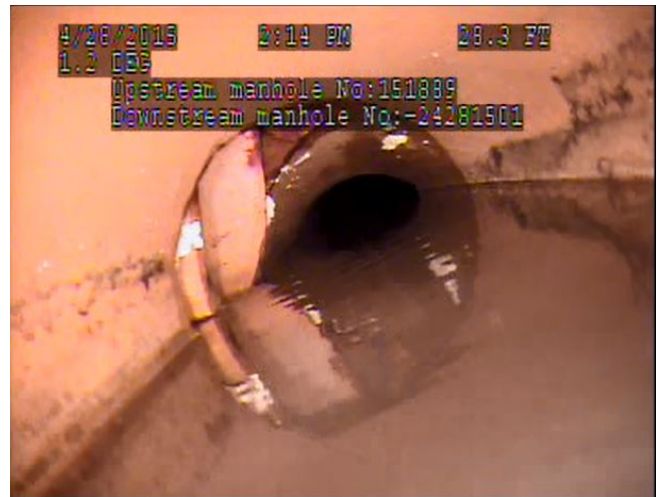
Near Collapse
